NRL Memorandum Report 3795

**Shock and Vibration Performance of an Epoxy
Chocking Compound Chockfast Orange,
PR-610CF (Philadelphia Resins Corp.)**

E. W. CLEMENTS

June 1978

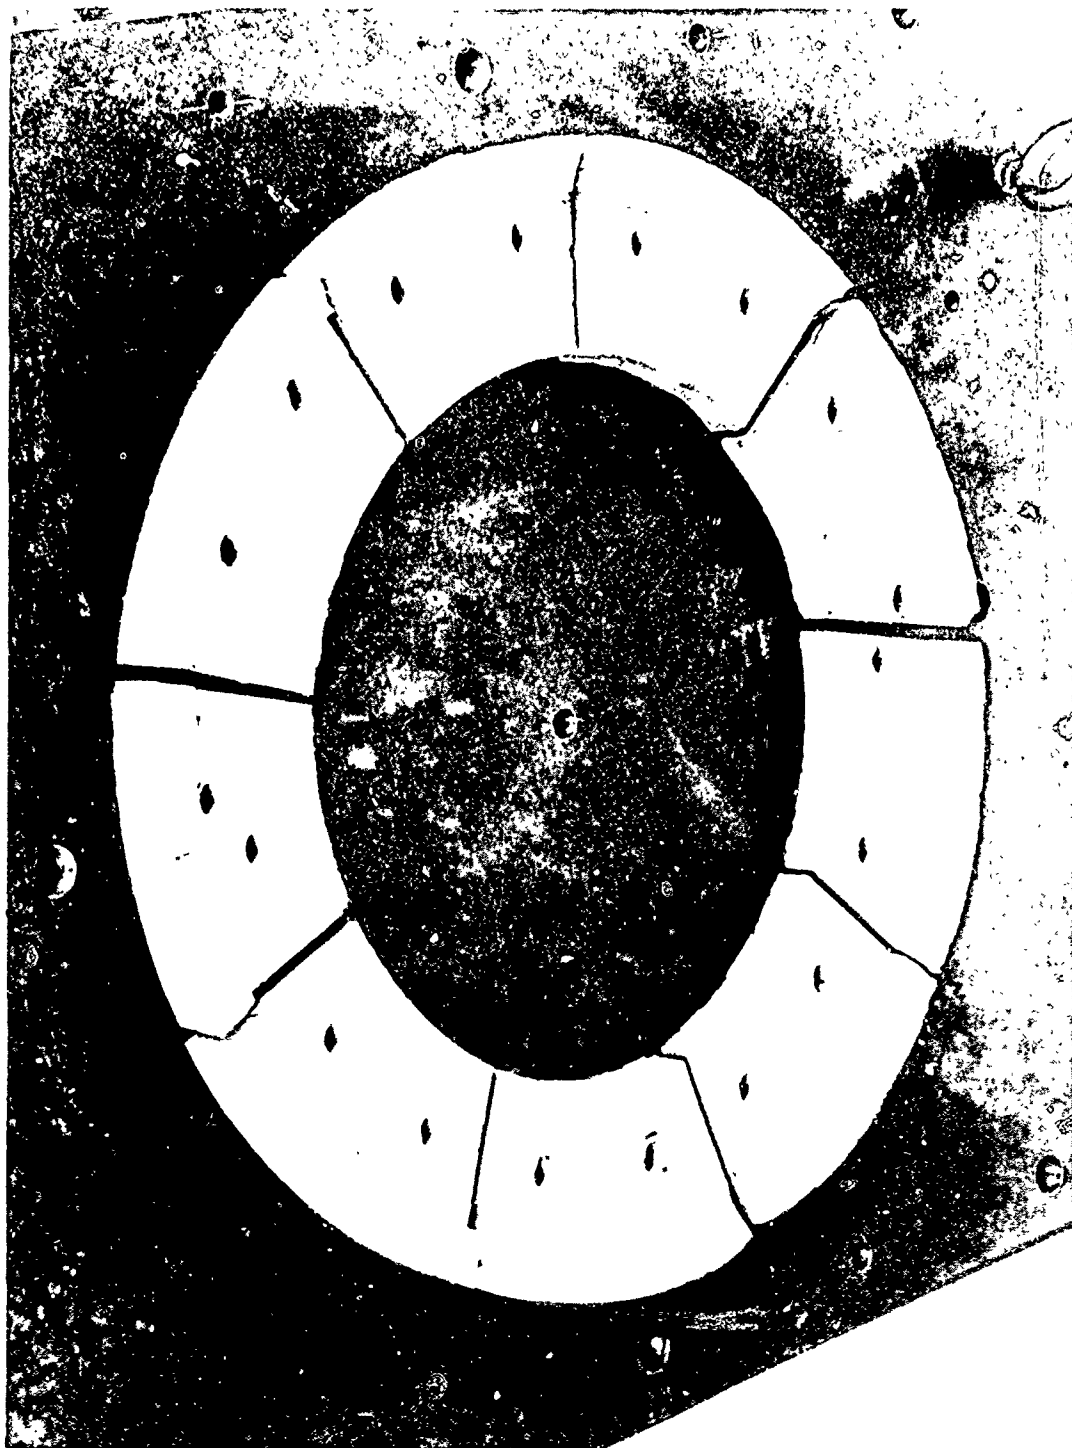
Finally, Figure 4 reveals some chipping and spalling in the overpour regions (Pad 7, particularly) which occurred when the pads were cut apart. Figure 5 shows the mounting ring and chock pads of Test Structure No. 2 after removal of the circumferential dams, and Figure 6 the top and Figure 7 the bottom surfaces of the chock pads after disassembly and separation. The general appearance is much the same as that of the pads for Structure No. 1, with slightly less porosity. After inspection and photography, the test assemblies were put back together and the hold-down bolts tightened to the desired torque. The static bearing load on the chock pads due to the weights of the test structures were negligible, only a few psi in either case. A total static load of 700 psi was chosen as the middle of the range of static loads recommended by manufacturer, and the bolt torque required to produce the necessary bolt tension calculated and rounded. For Test Structure No. 1 this torque was 50 ft. lb., and for Test Structure No. 2, it was 150 ft. lb. Calculated total bearing loads were 714 psi and 715 psi respectively. The mounting ring/chock pad was felt likely to be fairly flexible in comparison to the bolt stiffness, so that the total bolt load could approach the sum of the static and dynamic loads. Accordingly, hex-socket cap screws were used for hold-down bolts because of their high strength. The completed assemblies were then transferred to the NRL Shock and Vibration Lab, where the ambient temperature varied from 80 - 90 F during the period of the shock and vibration tests.

Fig. 4 — Chock pads of Test Structure No. 1 after separation. The continuous ring of overpour was cut with a bandsaw. Note the porous structure and occasional voids, as in Pad 1.

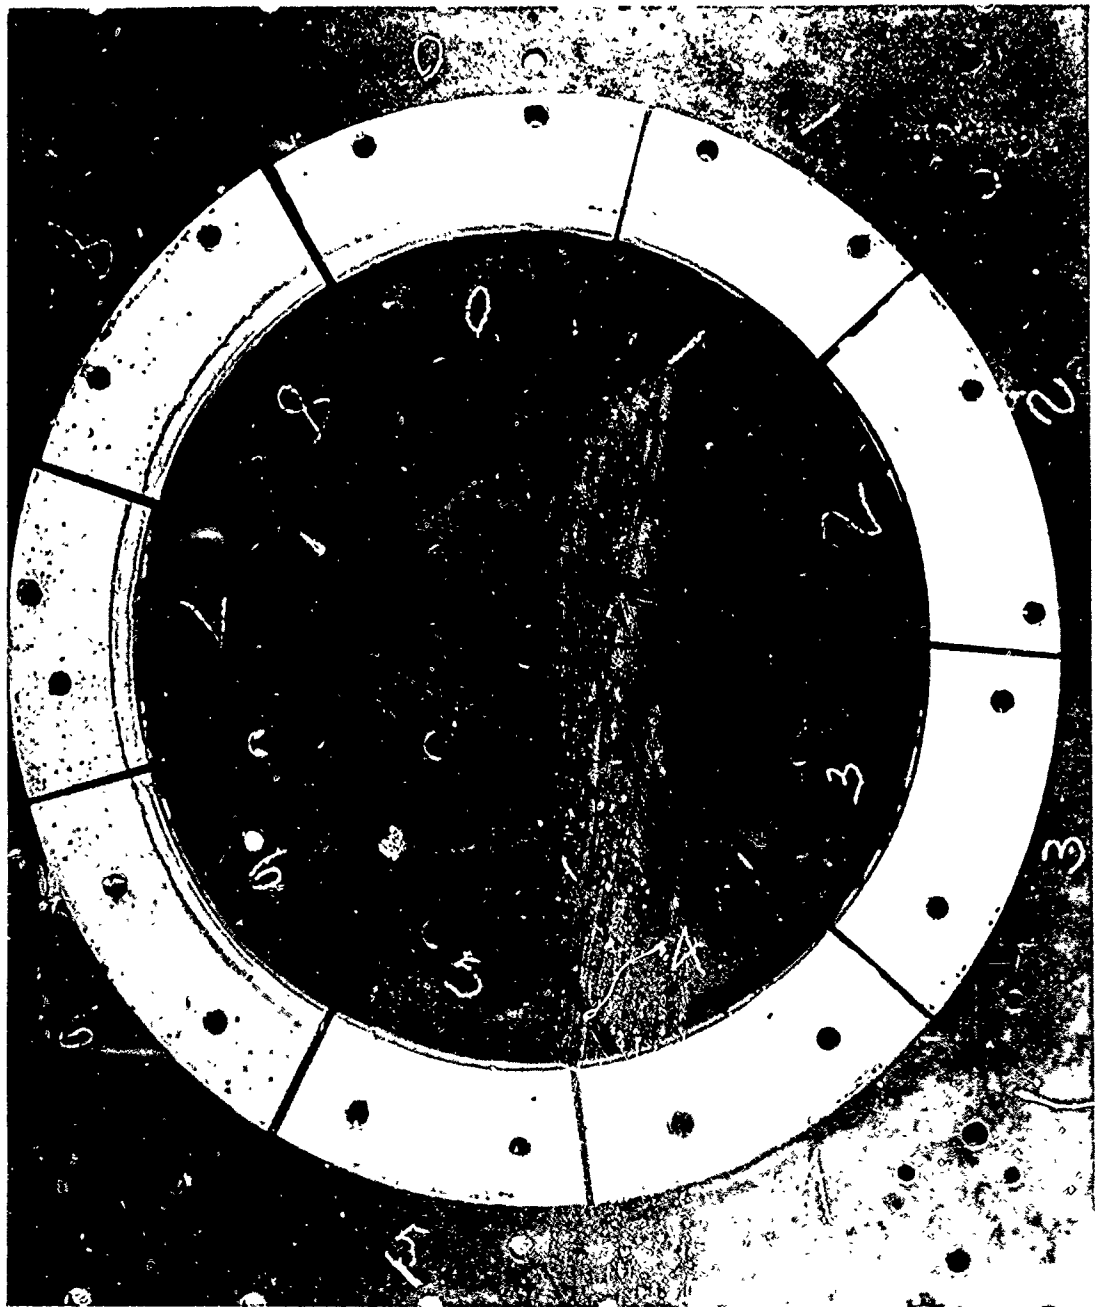
* Subsequent discussion with manufacturer personnel indicated that the mixing speed may have been higher than optimum, leading to more entrainment of air than usual. For Test Structure No. 2 the compound was mixed at about 100 rpm. The chock pads for this structure showed somewhat less, but still substantial, porosity. See Figs. 6 and 7.

Fig. 6 - Top surface of chock pads of Test Structure No. 2. Porosity and voids are slightly less pronounced than for Test Structure No. 1.

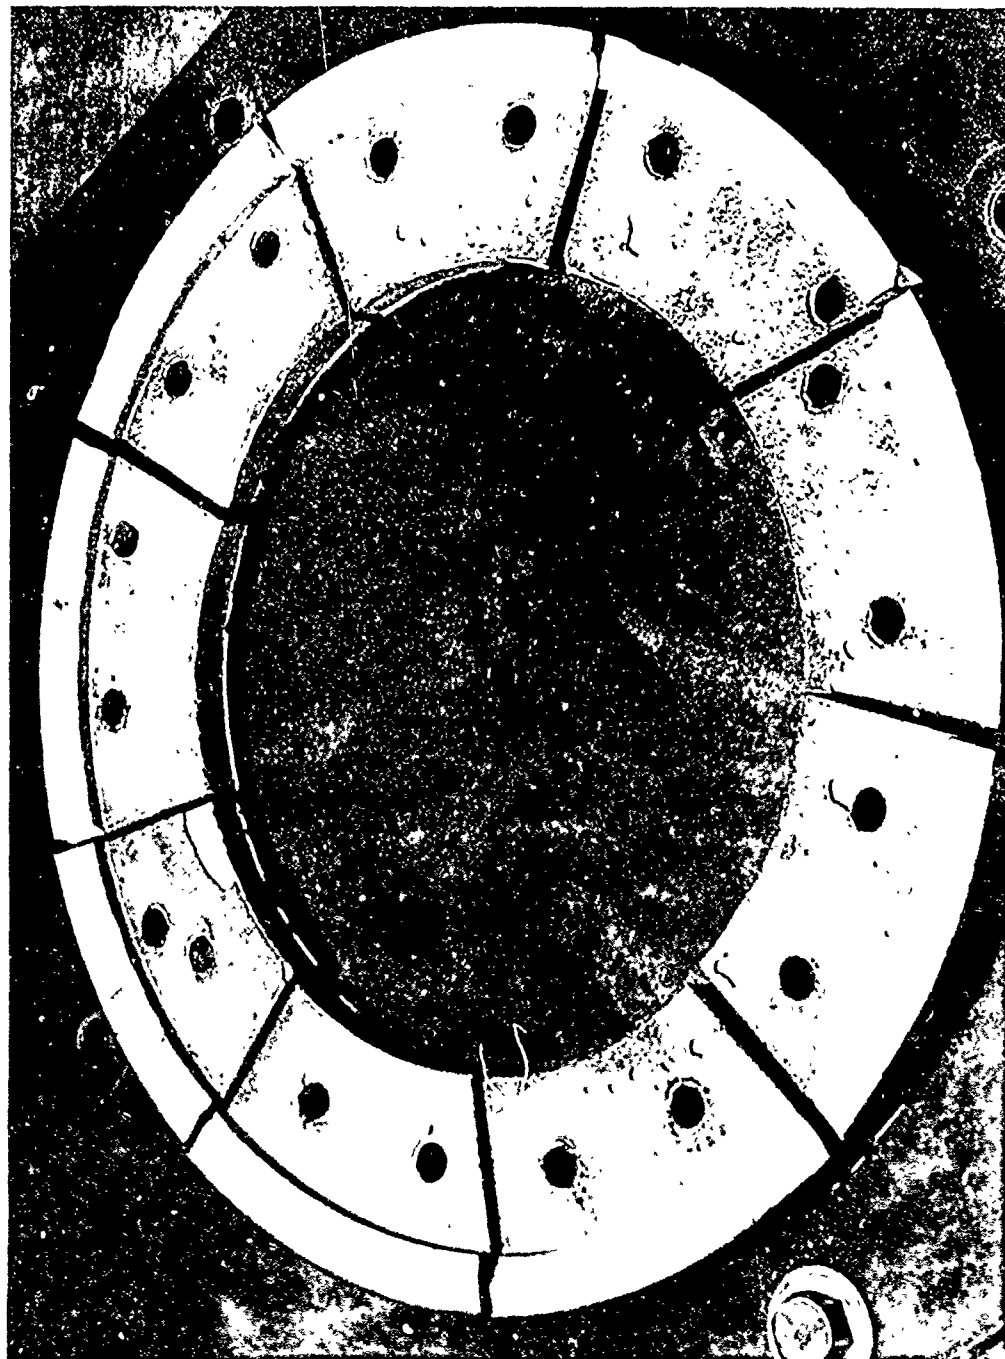
(Figure 9). No signs of damage or gross abrasion were found. The only notable change in appearance following the test was the appearance of a superficial stain on the upper surfaces, and to a lesser degree in the lower surfaces of the chock pads. This may indicate a transfer of surface material (scale, paint, etc.) from the mounting ring and mounting plate to the chock pads and would presumably indicate working between mating surfaces.

Fig. 9 — Chock pads of Test Structure No. 1 after vibration tests. The only change from Fig. 4 is the addition of a superficial stain which may indicate working between the mating surfaces. No signs of wear or abrasion are noticeable.

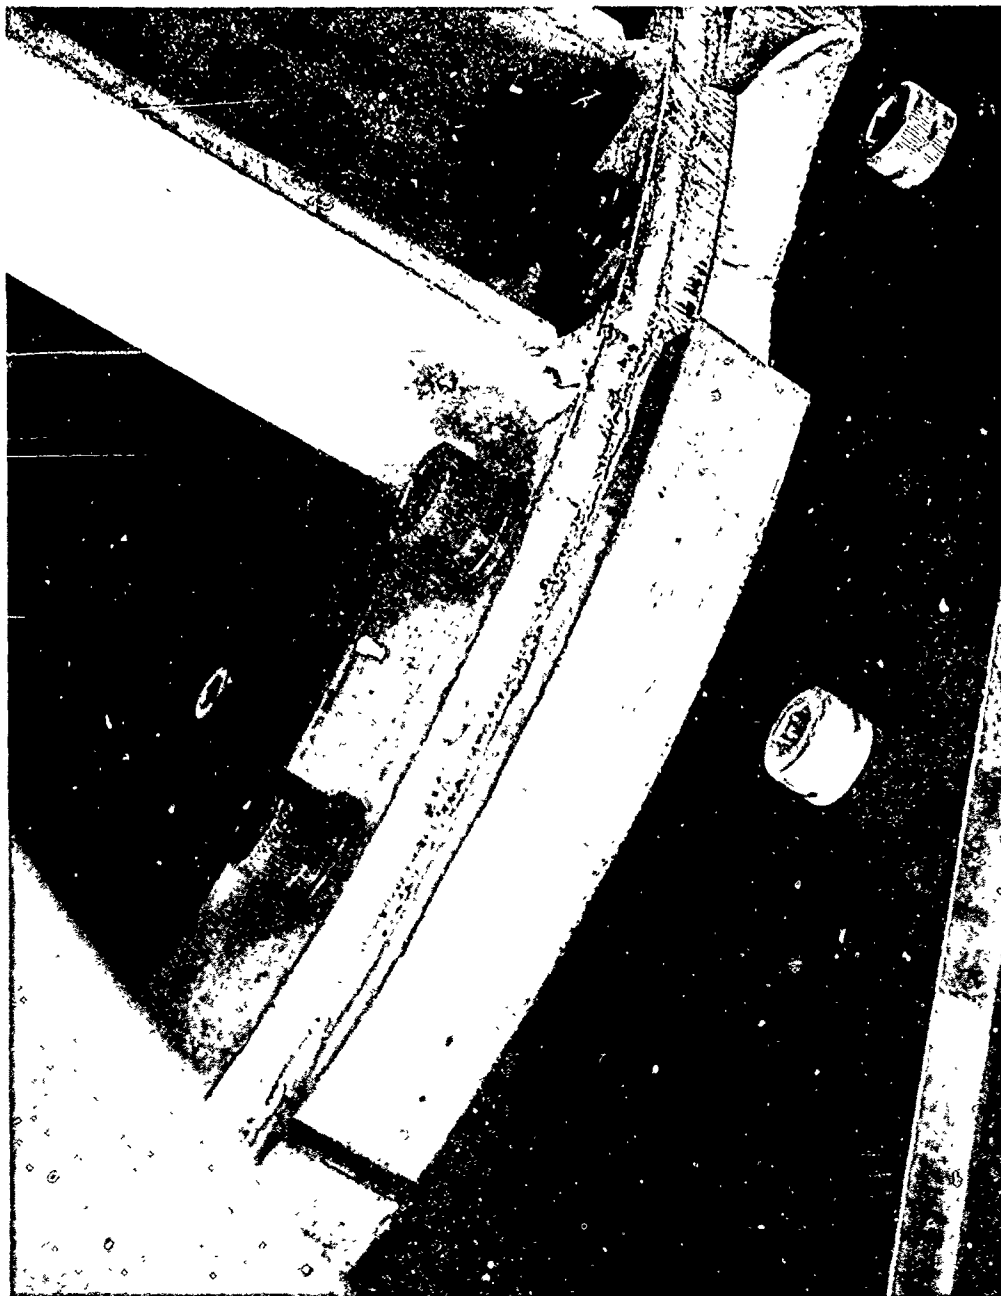
About two-thirds of the overpour region of Pad 3 spalled off (Fig. 12), but without visible damage to the load-bearing area.

Fig. 12 — Damage to Pad 3 of Test Structure No. 1 caused by Blow 4. A section of the over-pour region was spalled off, but the load-bearing area is not significantly affected.

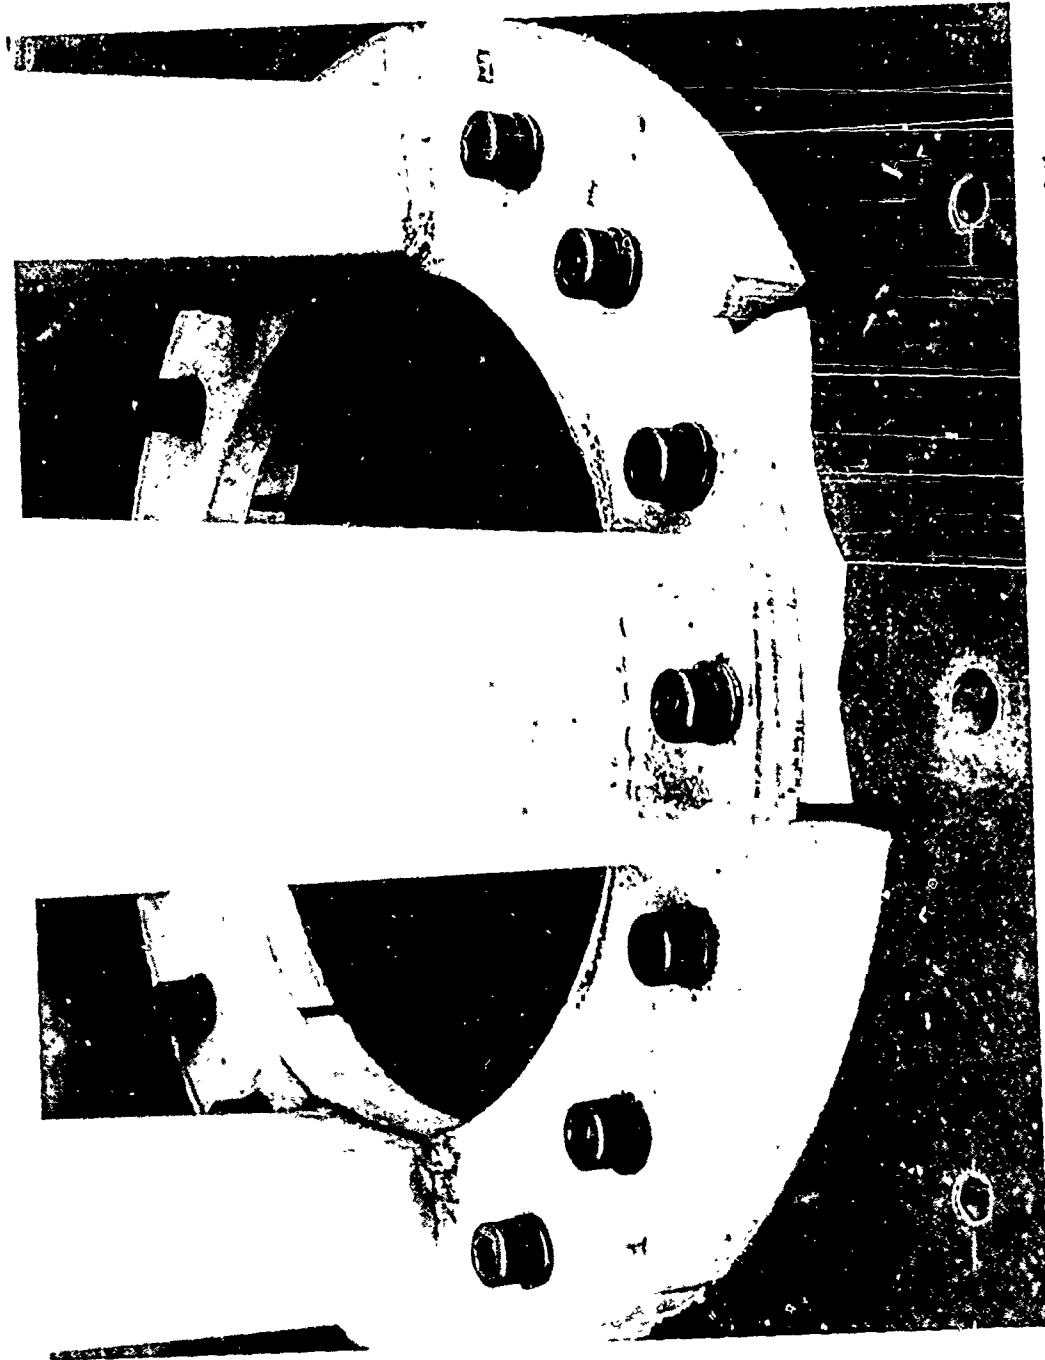
The remainder of the overpour volume of Pad 3 broke off (Fig. 13), still with no apparent damage to the load-bearing area.

Fig. 13 — Damage to Pad 3 of Test Structure No. 1 due to shock test. The rest of the overpour region spalled off during Blow 5, still without significant involvement of the load-bearing area.

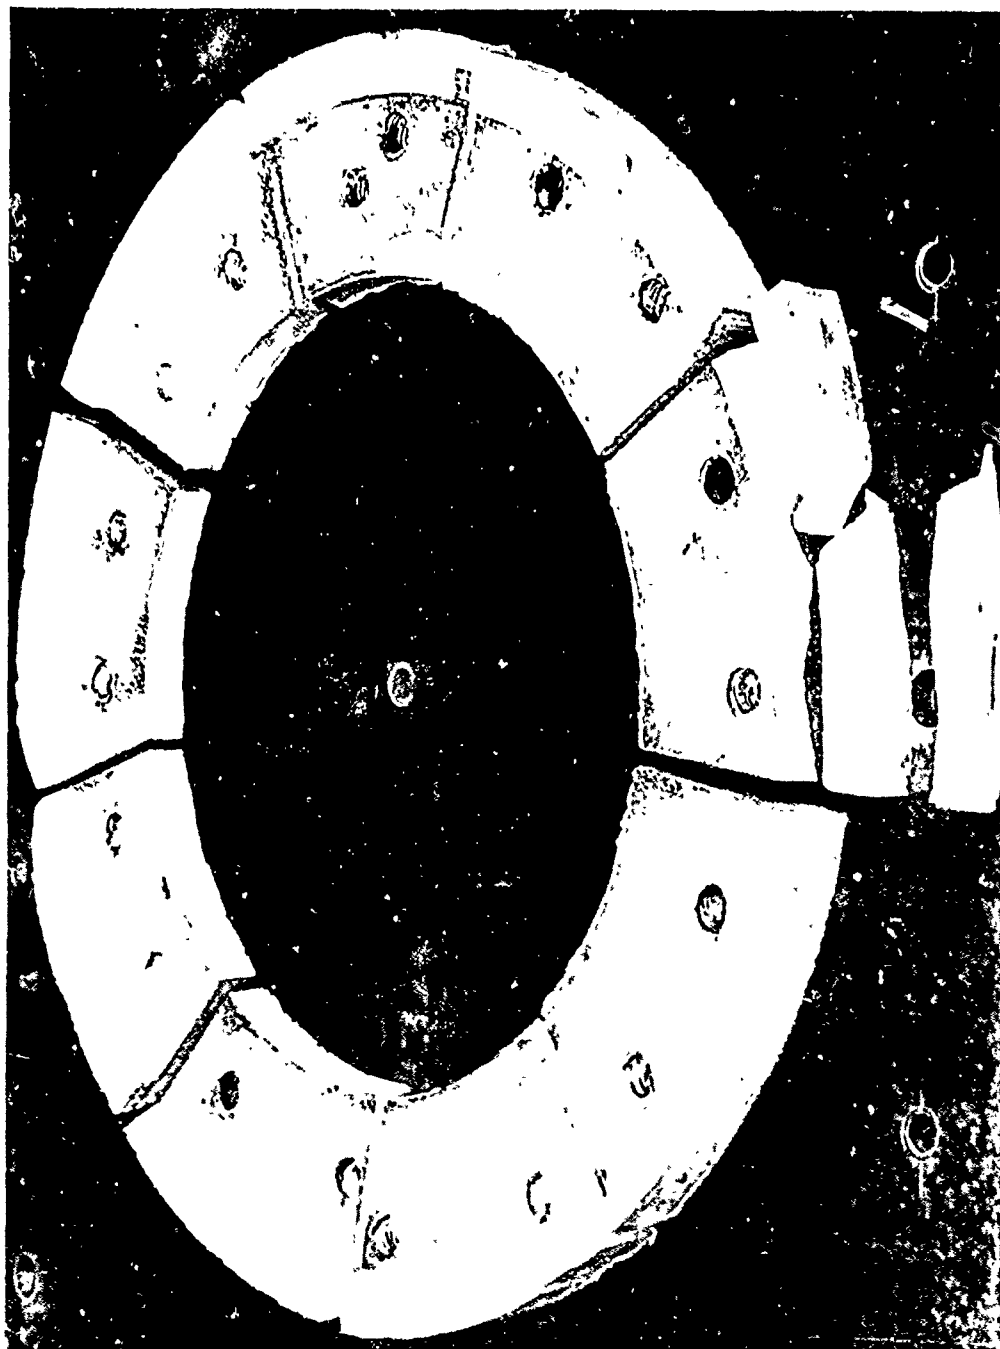
The test structure assembly was then taken apart for the last time. Except for the cracking and spalling noted above, the condition of the chock pads seemed unchanged by the shock test. Figure 14 shows the chock pads in their final state, with the three fragments which had successively spalled off Pad 3. Figure 15 shows the crack in Pad 6, and probably indicates how the cracking of Pad 3 progressed after initiation at the high-stress zone at the corner of the mounting ring.

Fig. 14 — Chock pads of Test Structure No. 1 after completion of shock and vibration tests.

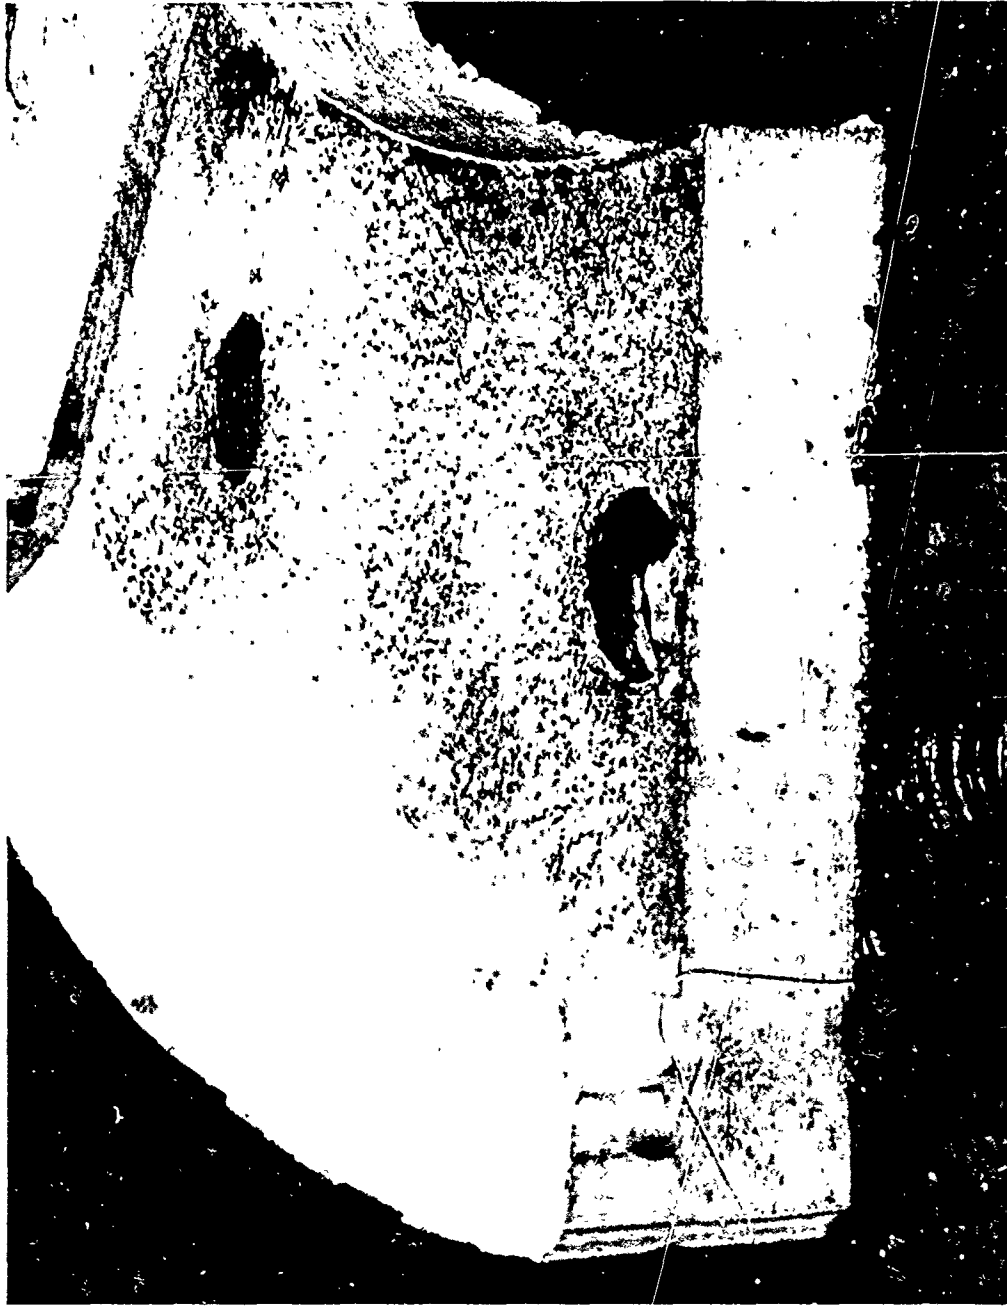
The test structure assembly was next disassembled and the chock pads inspected. A crack was found in Pad 6 (diametrically opposite Pad 2) between the overpour region and the load-bearing area, apparently an early stage of the cracking process which had led to the spalling of Pad 3.

A small fragment of Pad 3 spalled off under the outer edge of the mounting ring. The crack previously noted in Pad 6 progressed completely through, but without spalling off.

Fig. 15 — Cracks in Pad 6 of Test Structure No. 1 following shock and vibration tests. The pattern of cracking appears to be one which would progress to produce spalling such as occurred in Pad 3.

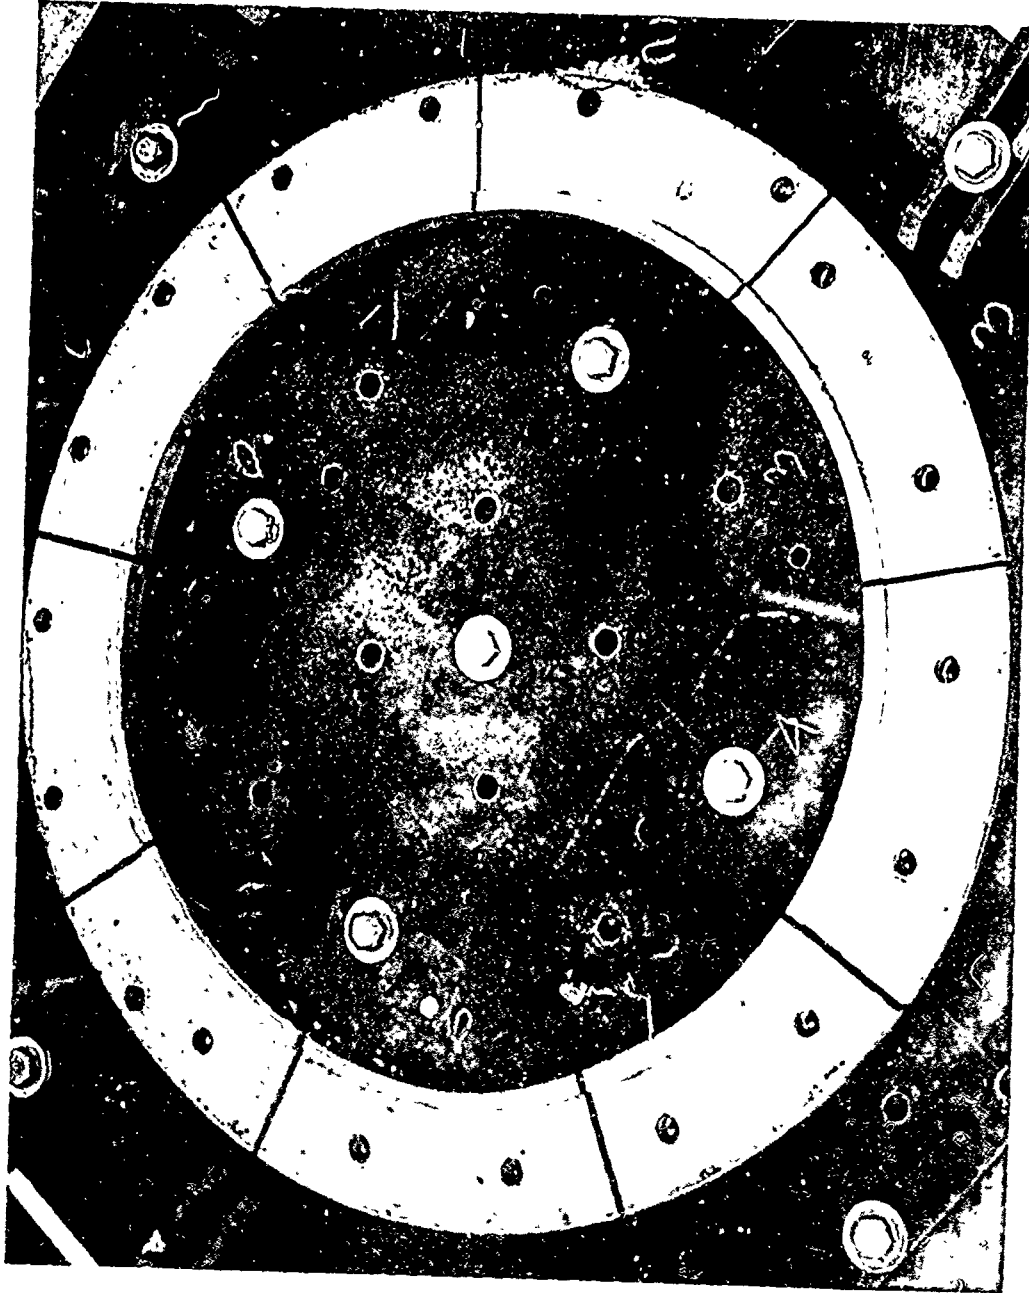
Figure 18 shows the chock pads following completion of the vibration test. Little or no change from the original condition could be found (compare Figure 6), save for slight surface discoloration in spots. The general surface discoloration noted for Test Structure No. 1 was absent.

Fig. 18 — Chock pads of Test Structure No. 2 following vibration testing. General surface staining such as that noted with the pads of Test Structure No. 1 is not apparent.

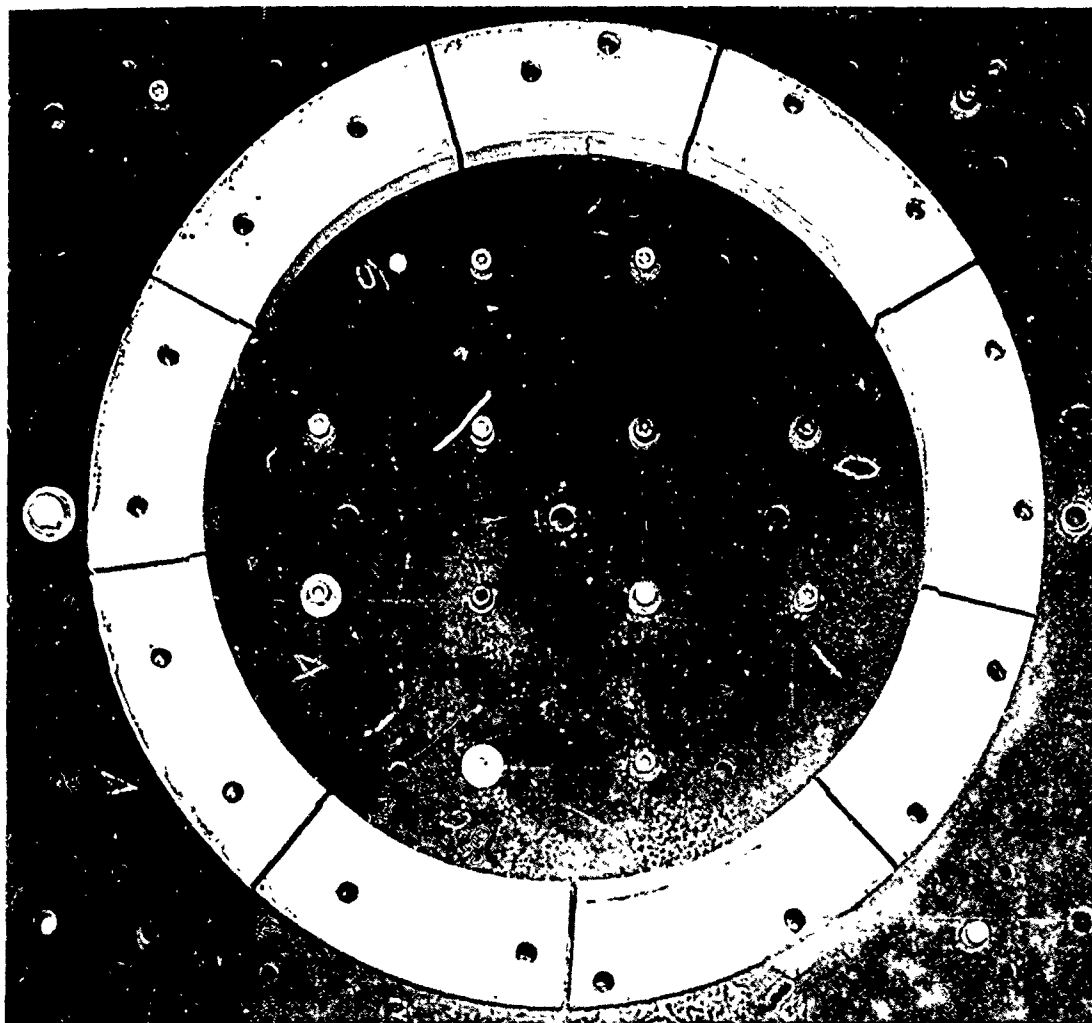
The test structure assembly was disassembled and the chock pads inspected and photographed (Fig. 21). No change in their condition could be seen.

Fig. 21 — The chock pads of Test Structure No. 2 after the standard shock test. The markings visible around the outer edges of Pads (4 & 5, for example) are patchy discoloration rather than abrasions.

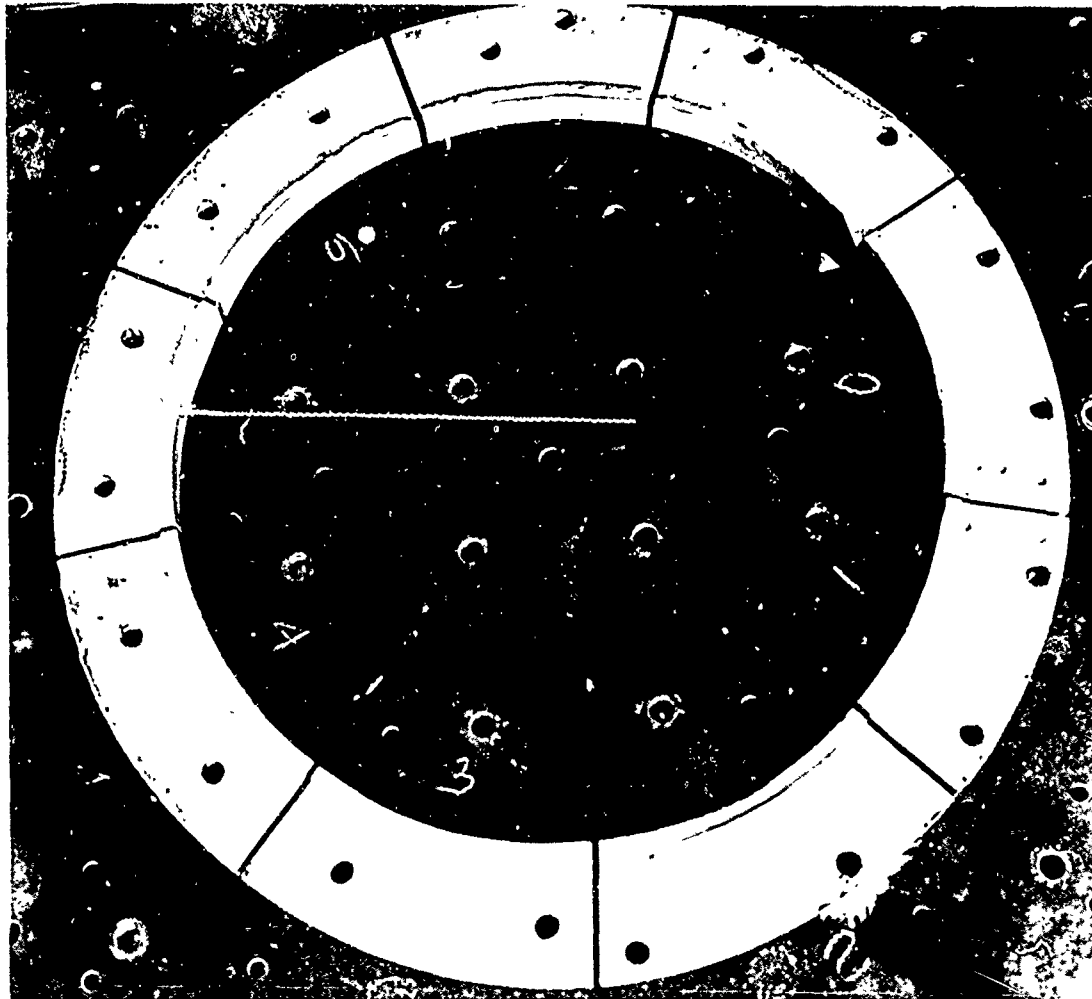
Figure 22 shows the chock pads after the completion of testing. Save for the chipped corner of Pad 8 and some spots of surface discoloration, there appeared to be no change in their condition since the initial post-curing inspection.

Fig. 22 — The chock pads of Test Structure No. 2 after completion of shock and vibration tests. The corner of Pad 8 spalled off on Blow 8, one of the extra blows with hold-down bolts loosened. No additional damage was caused by Blow 9.
